Prepared for:
Dairyland Power Cooperative
La Crosse, Wisconsin

Prepared by:
AECOM
Sheboygan, Wisconsin
60280210
October 2014

Wetland Delineation, Stream Survey, and Natural Heritage Inventory Habitat Survey Report

**Dairyland Power Cooperative
Briggs Road Substation to La Crosse Tap (Q-1D South) 161 kV Rebuild Project
La Crosse County, Wisconsin**

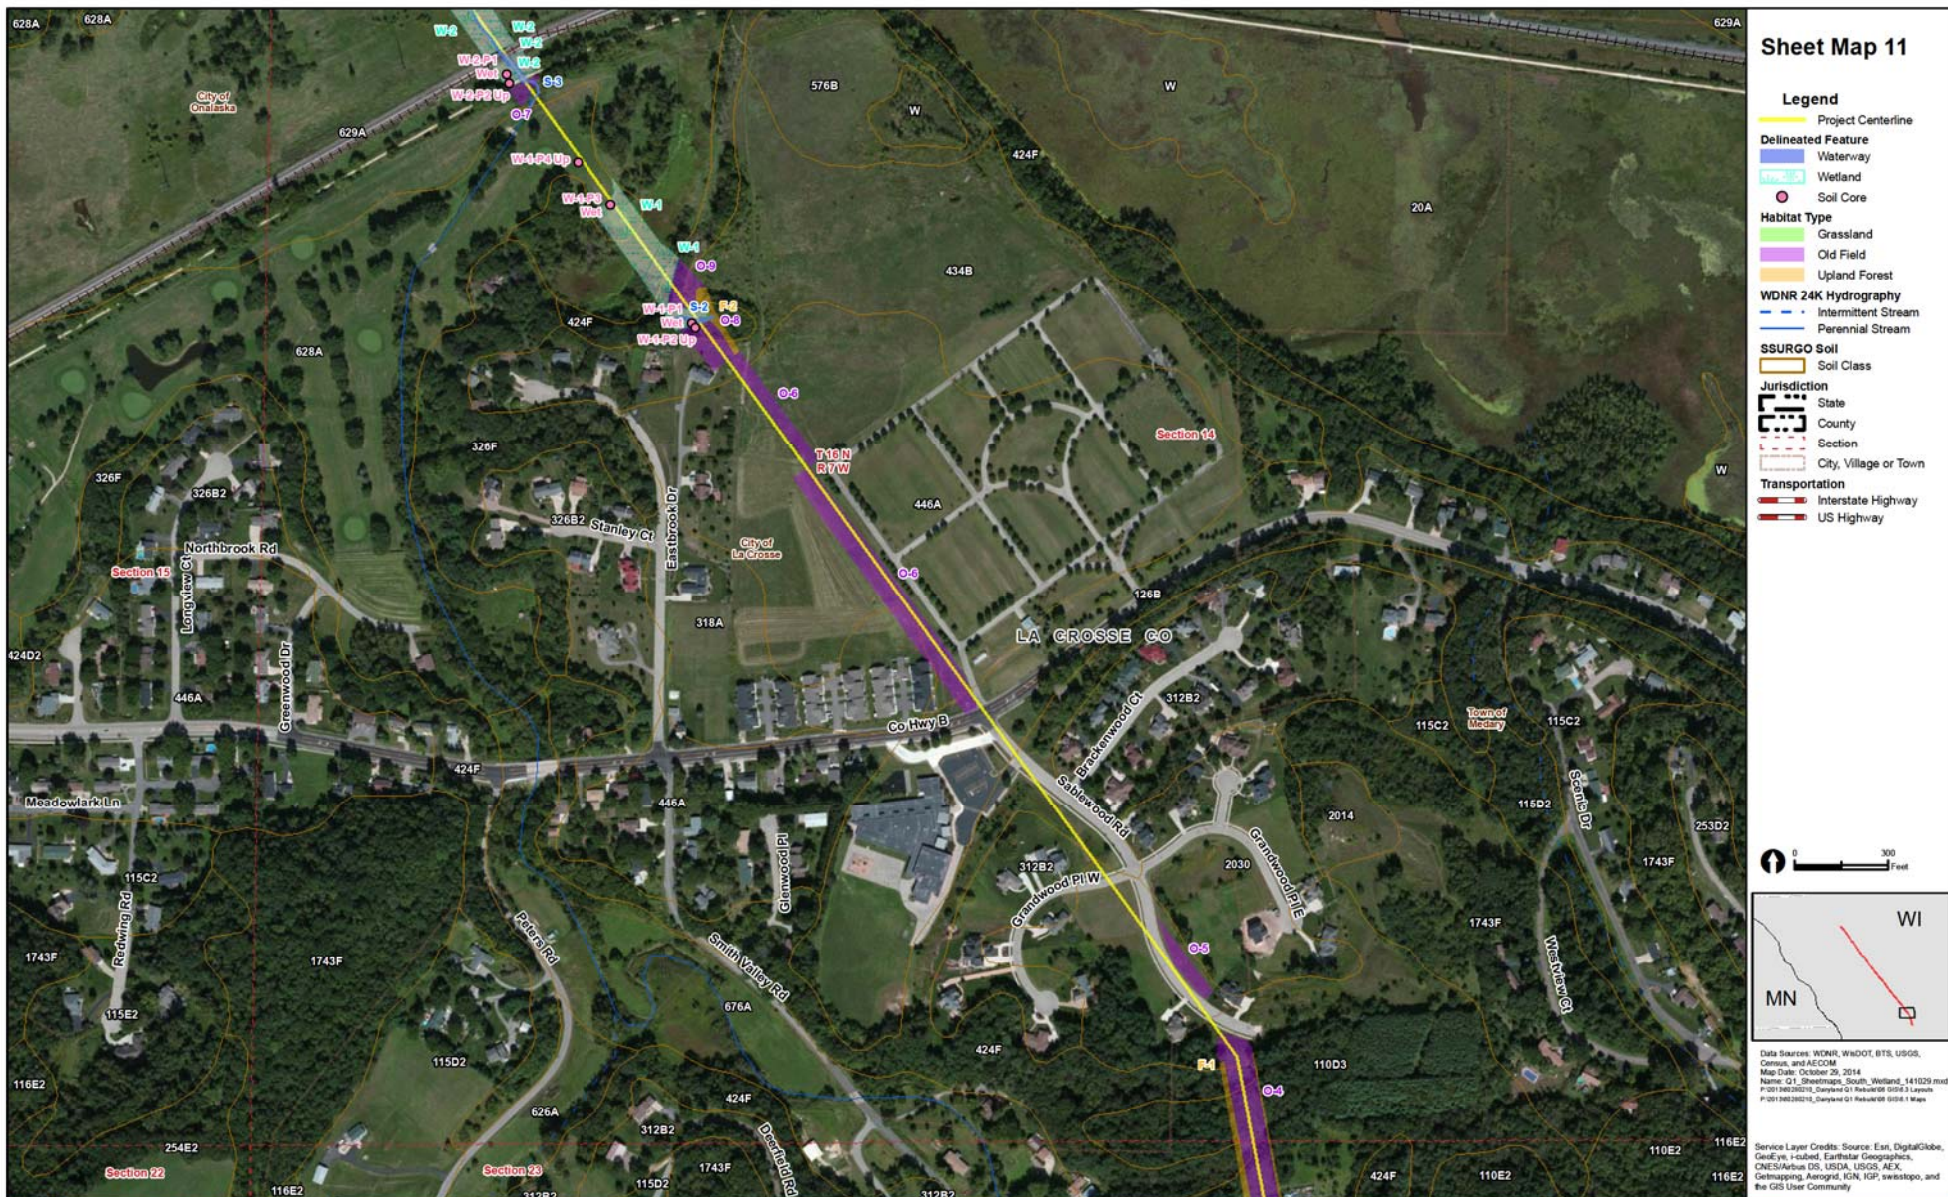
Sheet Map 11

Wetland W-1 is a wet meadow located north of the residential development along Eastbrook Drive and south of the Walsh Golf Center. Wetland W-1 is dominated by reed canary grass (*Phalaris arundinacea* - FACW) and American manna grass (*Glyceria grandis* - OBL). Wetland hydrology was evidenced by high water table, saturation, water-stained leaves, drainage patterns, and geomorphic position. Wetland criteria were met in this area due to the dominance of hydrophytic vegetation, positive wetland hydrology indicators, and the presence of hydric soils. Wetland W-1 was evaluated to have medium wetland functional values and is shown on **Figure 2, Sheet Map 11**.

Stream S-2 is also an UNT to the La Crosse River. The area adjacent to S-2 includes residential development to the south and adjacent wetland (W-1). The channel is approximately 6 feet wide with 3 foot banks. The channel has a silt substrate and no flowing water was observed at the time of the field survey. Stream S-2 is not classified on the WDNR Designated Waters map. S-2 is shown on **Figure 2, Sheet Map 11**.

Stream S-3 is also an UNT to the La Crosse River. The land use adjacent to Stream S-3 includes a golf course, pedestrian path, and railroad corridor on the south end and a large wetland complex to the north (W-2). The channel is approximately 6 feet wide with 3 foot banks. Stream S-3 has a silt substrate and 1 foot of flowing water was observed at the time of the field survey. Stream S-3 is classified as a perennial stream on the WDNR Designated Waters map. S-3 is shown on **Figure 2, Sheet Map 11**.

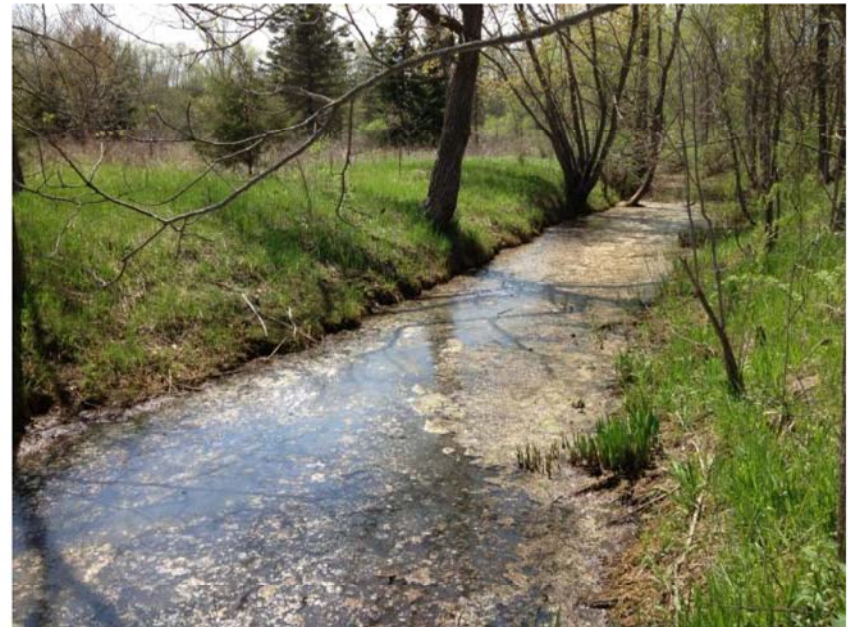
Photo 28: S-5 - Southeast

Stream S-5 is another UNT to the La Crosse River and appears to have been excavated and/or dredged. The land use adjacent to Stream S-5 includes grassland, forested floodplain, and old field habitat. The channel is approximately 9 feet wide with a 4 foot bank height and a silt substrate. Two feet of flowing water was observed at the time of the field survey. Stream S-5 is not classified on the WDNR Designated Waters map. S-5 is shown on **Figure 2, Sheet Map 10**.

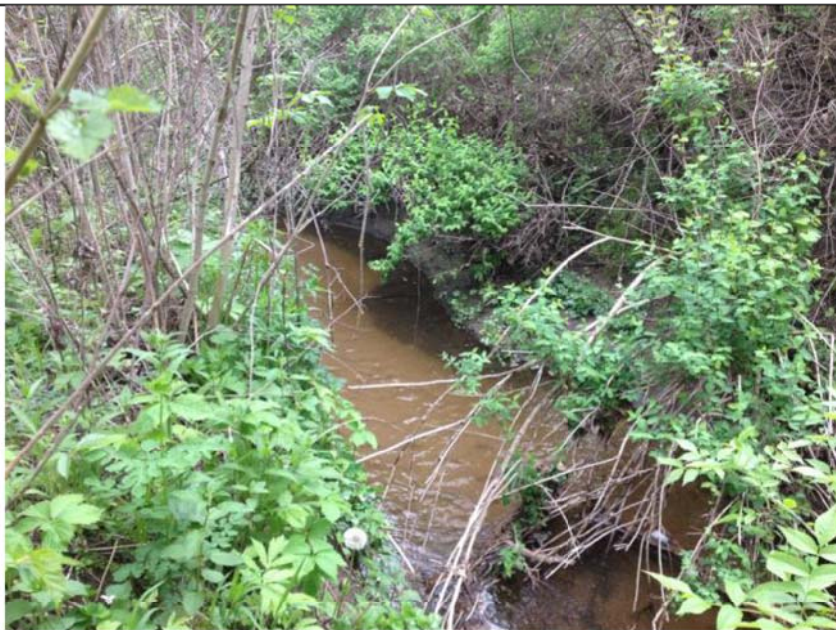
Photo 81: S-9 - East

Stream S-9 is an unnamed stream located east of County Highway XX. The land use adjacent to Stream S-9 includes Southern Mesic Forest upland habitat. The channel is approximately 8 feet wide with a 4 foot bank height and a sand substrate. One foot of flowing water was observed at the time of the field survey. Stream S-9 is classified as an intermittent and ASNRI stream for Endangered, Threatened, or Special Concern species on the WDNR Designated Waters map. S-9 is shown on **Figure 2, Sheet Map 3**.
