ENVIRONMENTAL ASSESSMENT

For the Proposed
Spring Creek 115kV Switching Station Construction Project
Miller County, GA

**Georgia Transmission Corporation
2100 East Exchange Place
Tucker, GA 30085**

November 2012

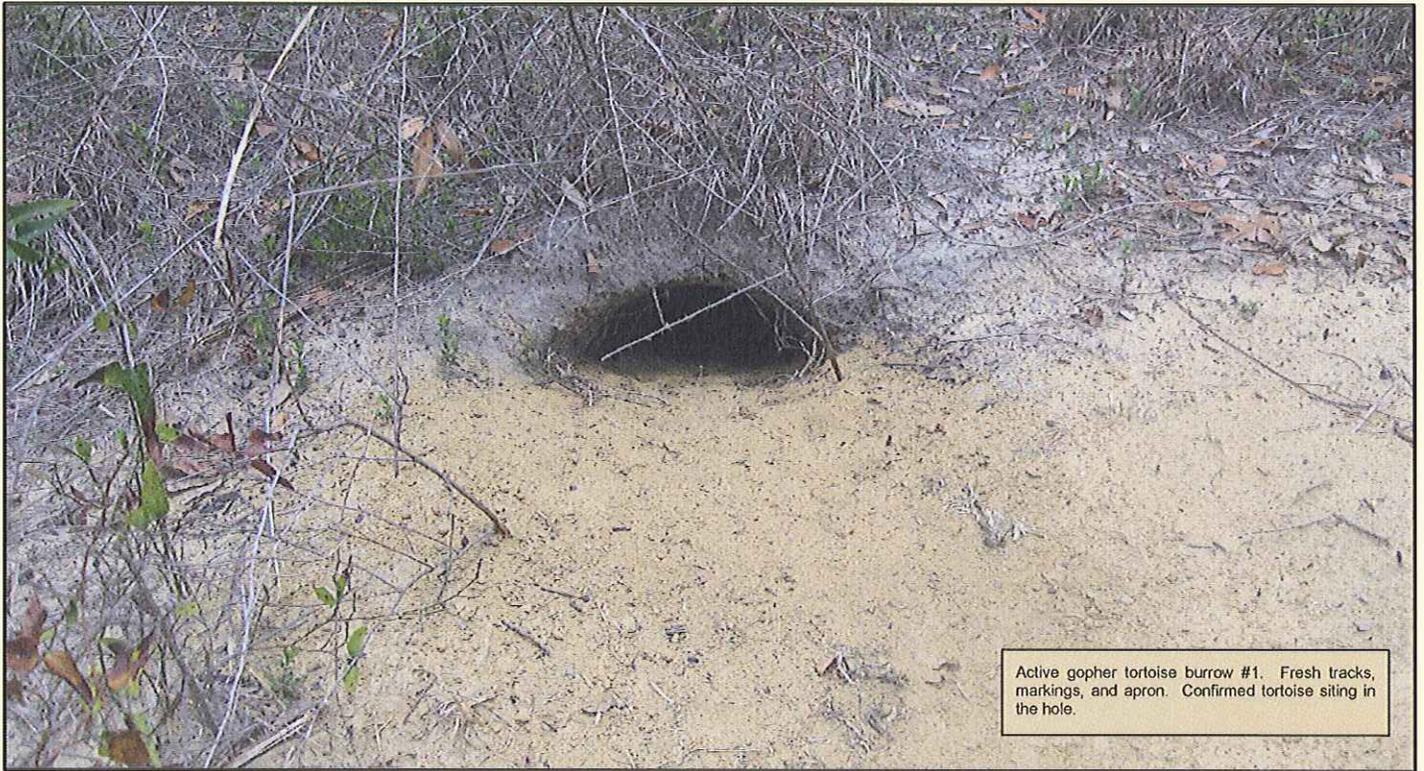
Active gopher tortoise burrow #1. Fresh tracks, markings, and apron. Confirmed tortoise siting in the hole.

During the pedestrian survey of the project area, five possible gopher tortoise burrows were identified within an existing transmission line ROW. Four of these holes are apparently abandoned and are not currently being used by the gopher tortoise. One, however, is active. Each hole was GPS located and flagged for easy identification in the field. Holes 1 and 2 were scoped with an infrared camera to determine the exact depth / composition of the burrow and to see if any gopher tortoises were in the burrow. Holes 3, 4, and 5 which are obviously inactive were found to be shallow and not inhabited by the gopher tortoise and were not scoped. Following is a description of each area evaluated by SECI, and photographs of each hole are attached to this report.

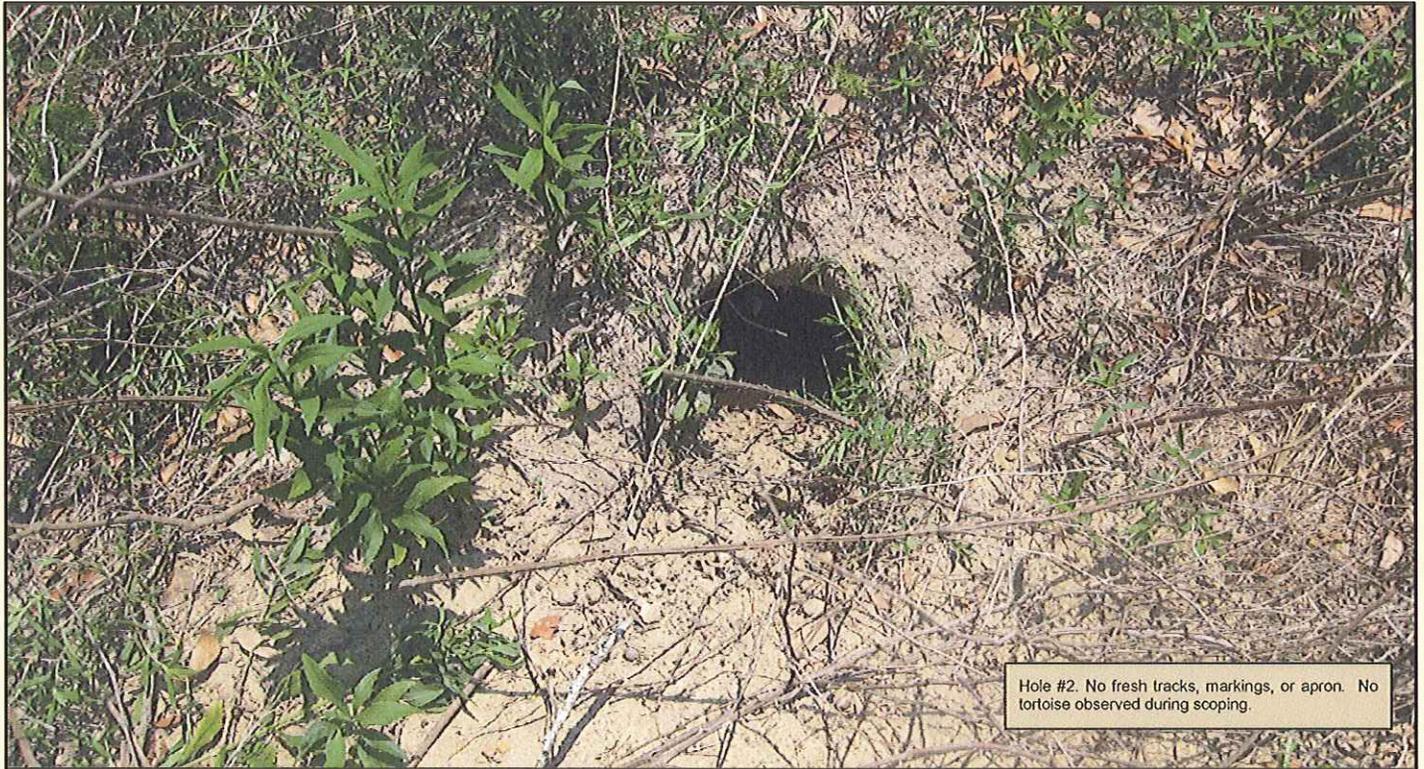
Hole #2. No fresh tracks, markings, or apron. No tortoise observed during scoping.

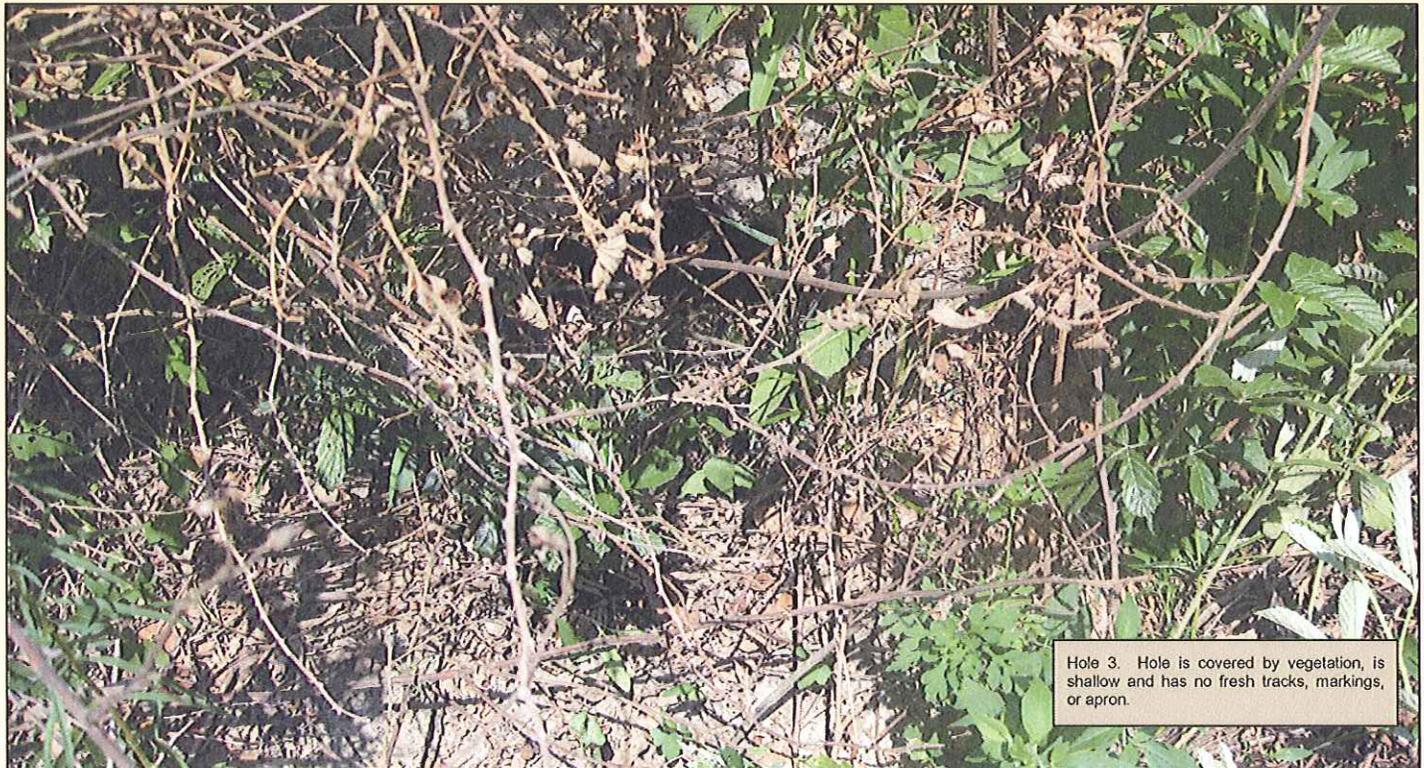
Hole 3. Hole is covered by vegetation, is shallow and has no fresh tracks, markings, or apron.

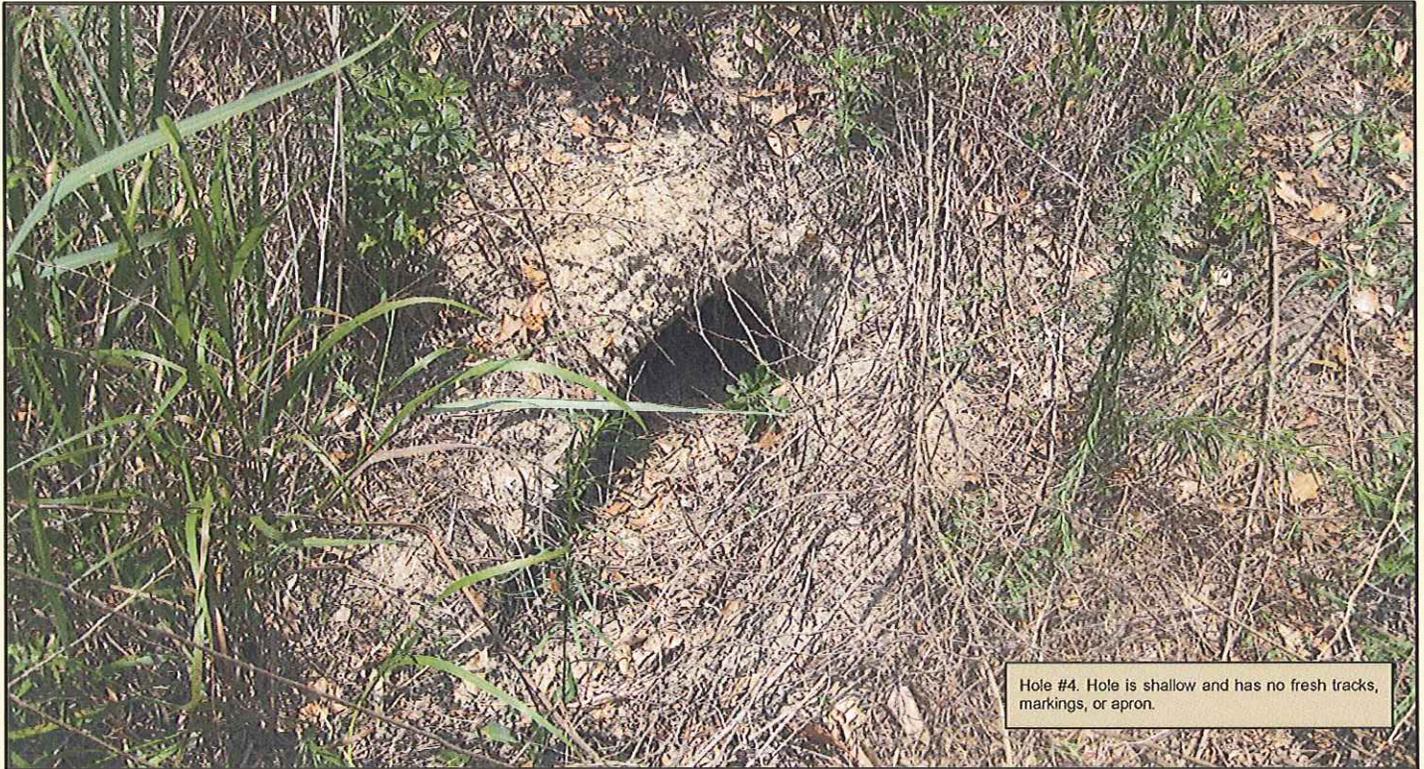
Hole #4. Hole is shallow and has no fresh tracks, markings, or apron.

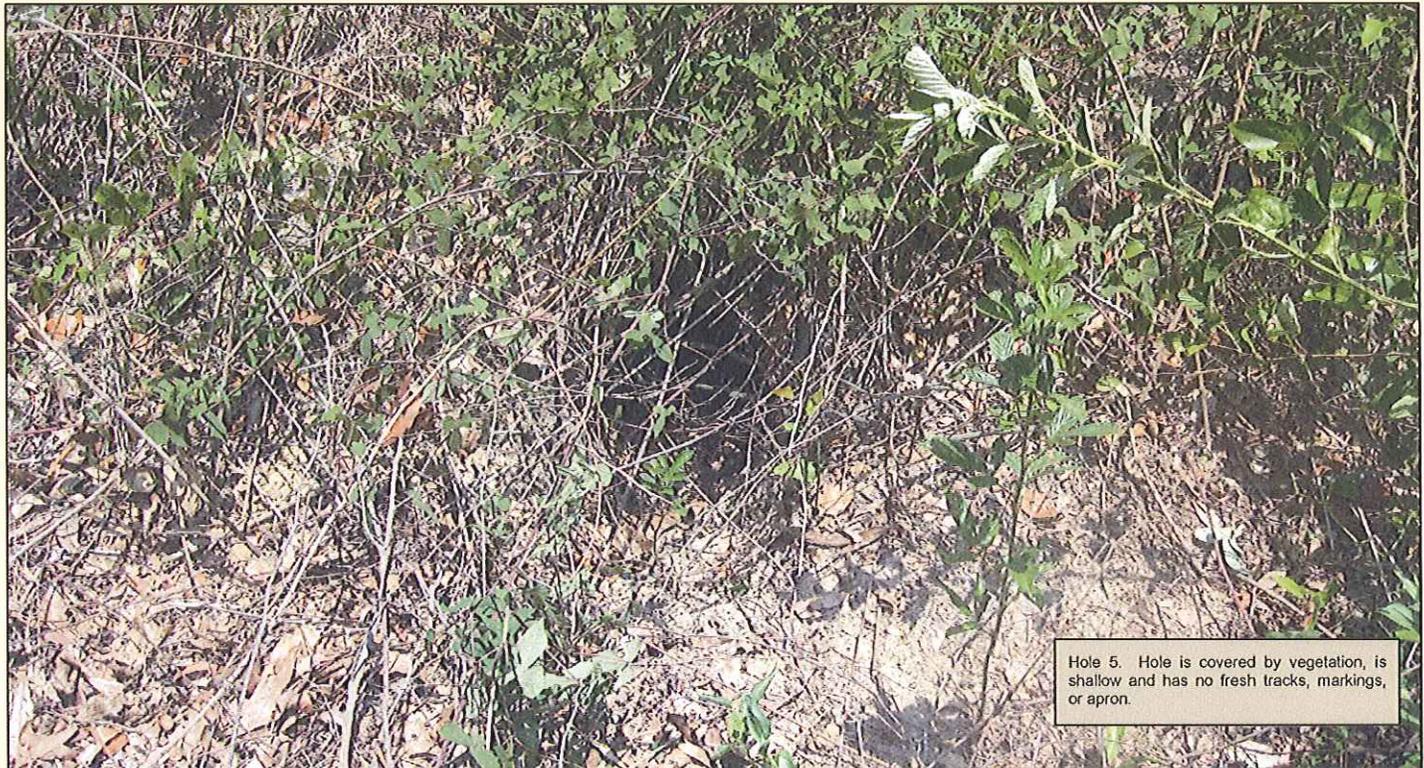
Hole 5. Hole is covered by vegetation, is shallow and has no fresh tracks, markings, or apron.
